Subject: AV-3000 Facepiece

Concerning SCOTT AV-3000® Facepieces

DATE: January 8, 2008

TO: All Users of SCOTT AV-3000® Facepieces

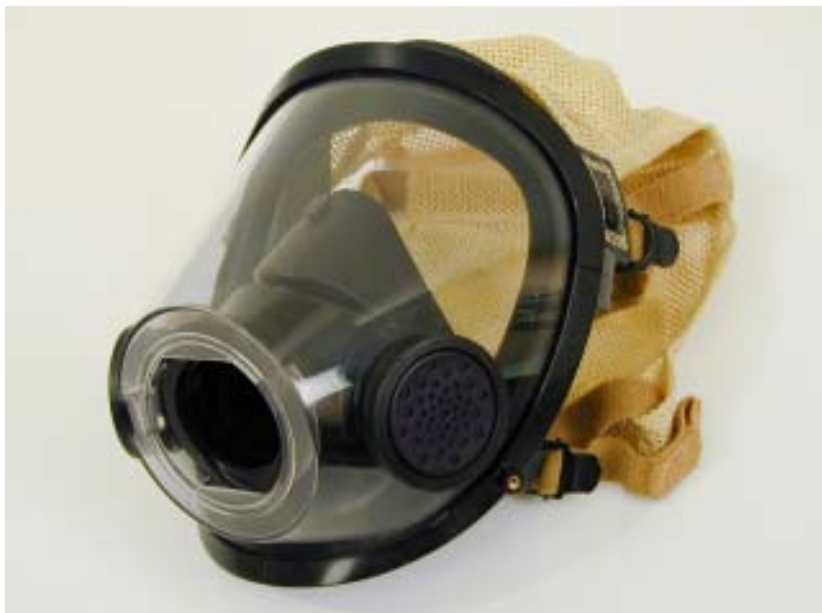
FIGURE 1
AV-3000 Facepiece

SCOTT has learned that some AV-3000 facepieces have separated at the rubber tab which connects the head harness to the facepiece seal and lens.

Based on laboratory testing, the force needed to damage the facesal is well beyond what is needed to properly don a facepiece and achieve a good face-to-facepiece seal. As a result, most users have not experienced damage to their equipment. To achieve a good face-to-facepiece seal, the AV-3000 facepiece requires less tension on the head harness straps than some of the other SCOTT Facepiece Models. This may lead some users to over tighten the straps on the AV-3000 facepiece.

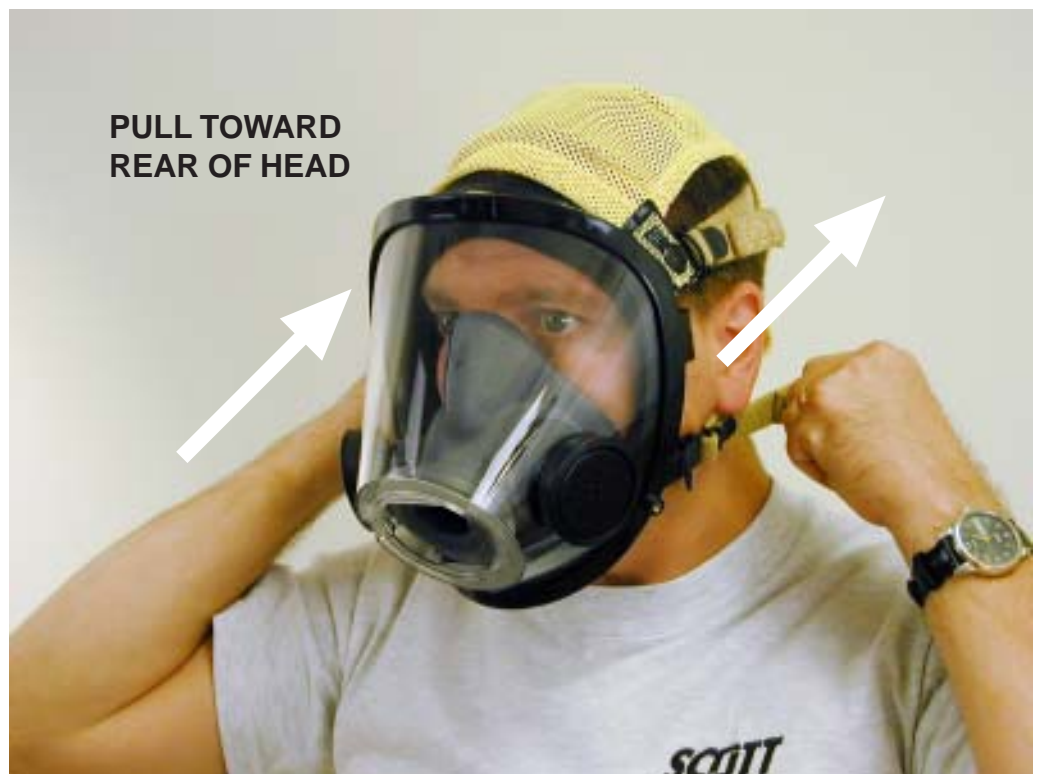
**FIGURE 2
PULLING THE TWO
LOWER STRAPS**

5. Tighten the neck straps by pulling the two lower strap ends toward the rear of the head.

6. Verify that the head harness is lying flat against the back of the head by stroking the harness using one or both hands. Retighten neck straps.

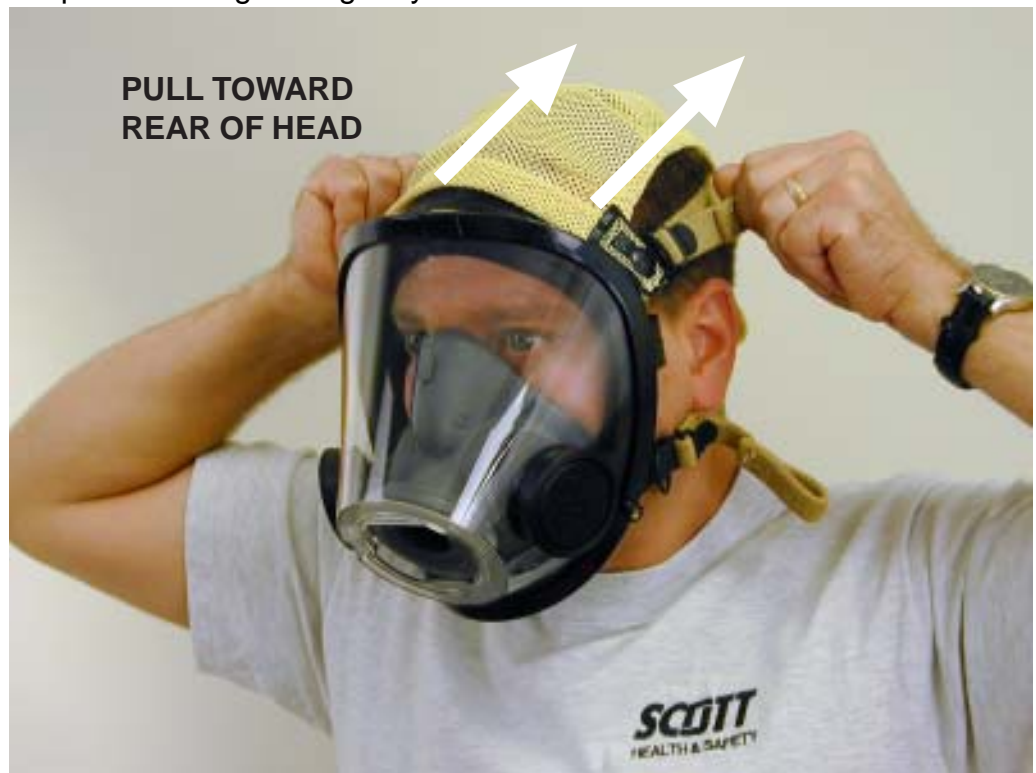
**FIGURE 3
PULLING THE TWO
UPPER STRAPS**

7. Adjust the temple straps by pulling the two upper strap ends toward the rear of the head. Use caution pulling temple straps as over tightening may cause discomfort.

When donning the facepiece the user should only pull hard enough to secure the facepiece to the head and achieve a good face to facepiece seal. To achieve a good face-to-facepiece seal, the AV-3000 facepiece requires less tension on the head harness straps than some of the other SCOTT Facepiece Models. This may lead some users to over tighten the straps on the AV-3000 facepiece. If you have any questions regarding donning a facepiece to achieve a good facepiece seal, contact the administrator of your organized respiratory protection program.
