FIREFIGHTER WARNING!!

NEW DRY WALL REINFORCED WITH LEXAN

Cutting Tools Required To Breach Hi-Impact Gypsum Wallboard

Test #1

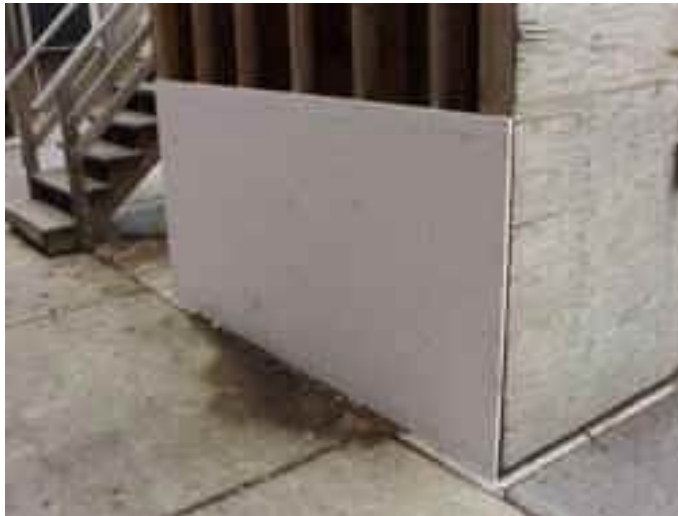
The test was conducted by utilizing 5 different hand tools that a firefighter will most likely have with him during firefighting operations. Each of the 5 different hand tools was used to attempt to breach the Hi-Impact 8000 Wallboard. The wall was constructed of wooden studs on 16" centers. The 4' x 8' sheet of wallboard was mounted to the studs using ordinary drywall screws. The wall is pictured below:

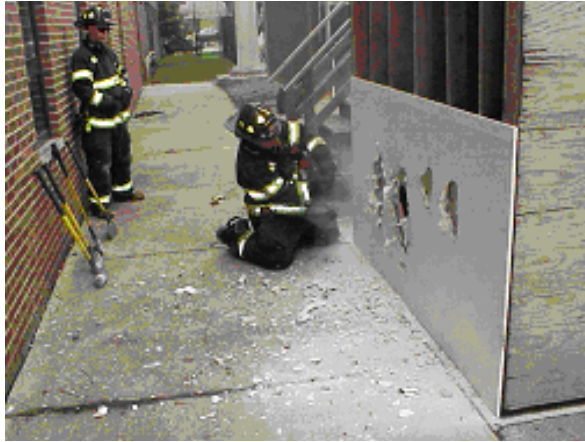
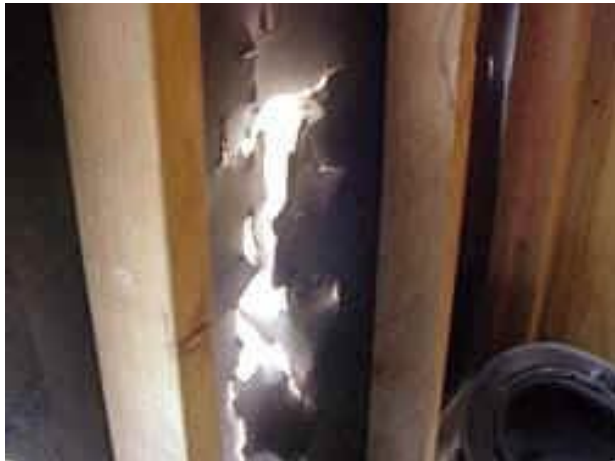
Additional Photos:

As shown in the table above, all of the striking tools were proven ineffective in breaching the Hi-Impact 8000 Wallboard. The cutting tools proved to be most effective, usually penetrating the Lexan in less than 10 swings. The Lexan did not break easily after being struck but it did crack enough to become pliable enough to bend while the firefighter crawled through the hole. One thing to consider while you are crawling through the wall, is the Lexan had tendency to get caught up on personal protective equipment and will possibly cut or rip the PPE with the sharp edges. Another consideration, is the amount of time it took to create a hole large enough to accommodate a firefighter's size. If fire conditions are deteriorating, the firefighter is already at increased risk. Also, this test was performed with the Hi-Impact 8000 Wallboard on only 1 side of the stud. Chances are, if this product is encountered, it will be mounted to both sides of the studs, therefore at least doubling the amount of time and effort to breach the wall in an emergency situation.
